Manhole Inspection Summary

Manhole # S15K__002MH

Insp Date: **4/2/08 10:20 AM**

Location Address: **300 stinson st**

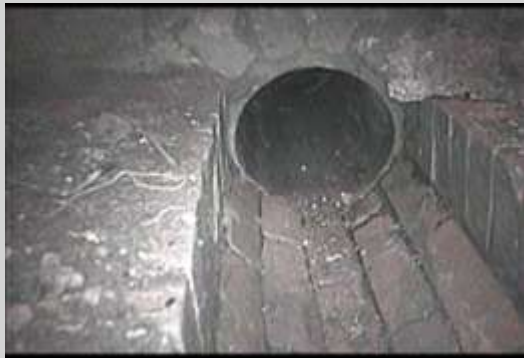
12 O'Clock Outflow

8 in. Circular Gravity Sewer
Pipe Out @ 12 O'Clock

Pipe Height: **8.4** (in.) Rod and Bar (Angled)
Pipe Material: **Clay** ☐ Pipe Lined
Invert Depth: **14.77** (ft.) Flow Characteristics: **None**
Deposits: ☒ None ☐ **Mud** ☐ Sludge ☐ Debris ☐ Grease
Silt Depth: **0** (in.) Deposits Extent:
Infiltration: **None** Pipe Seal Cond: **Sound**
